From: Steve Christensen
To: Pam Grubaugh-Littig
Date: 6/29/2007 11:11 AM
Subject: Fwd: emery subsidence
Attachments: Emery Subsidence 6-14-07.pdf

Consolidation Coal Emery Mine Subsidence Report for May 2007

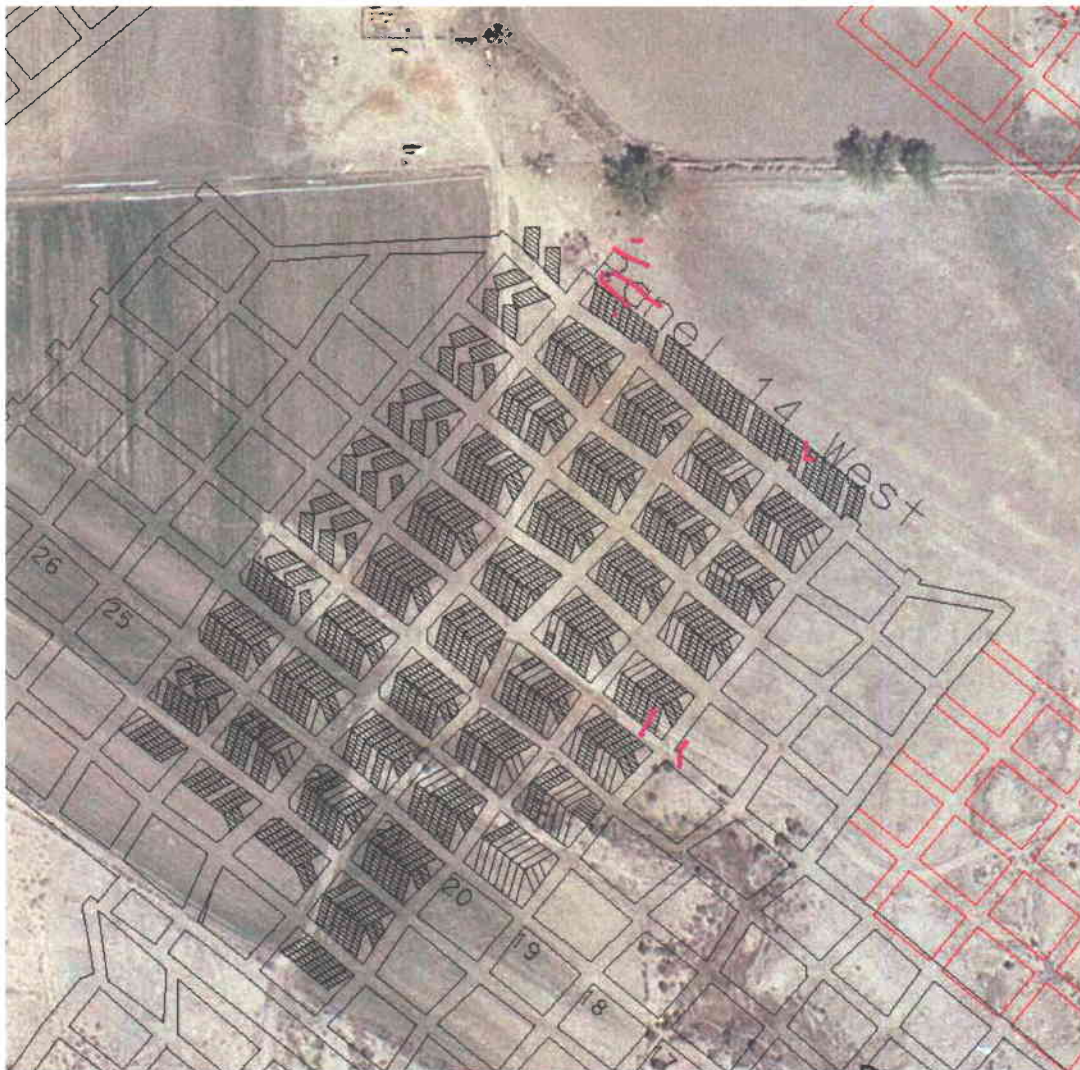
5-8-07	No subsidence noticed over Panel 14 West. PB
5-19-07	No subsidence noticed over Panel 14 West. PB
5-21-07	No subsidence noticed over Panel 14 West. PB
5-31-07	Subsidence noticed over Panel 14 West. PB
6-4-07	1 inch cracks found above Panel 14 West where pillaring. Marked locations with GPS. PB

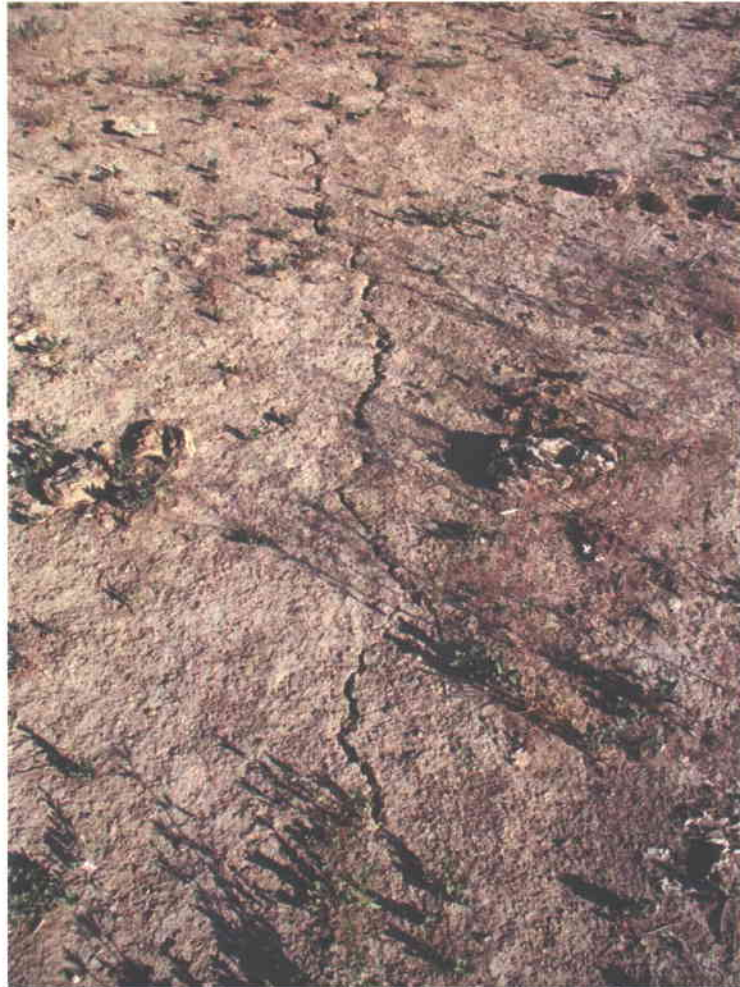
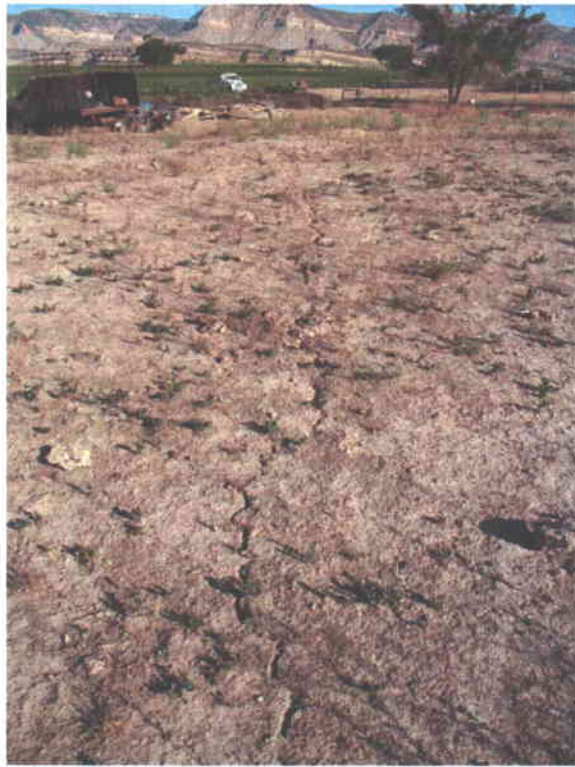
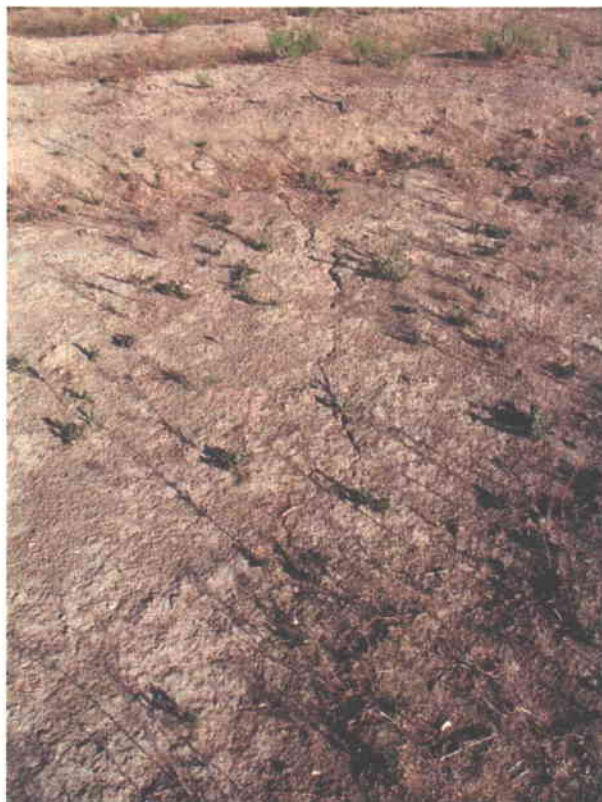
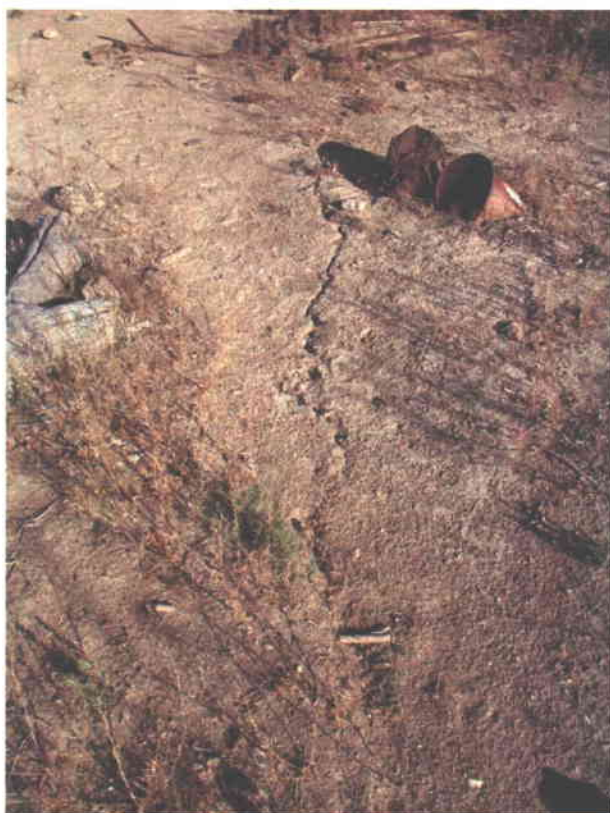
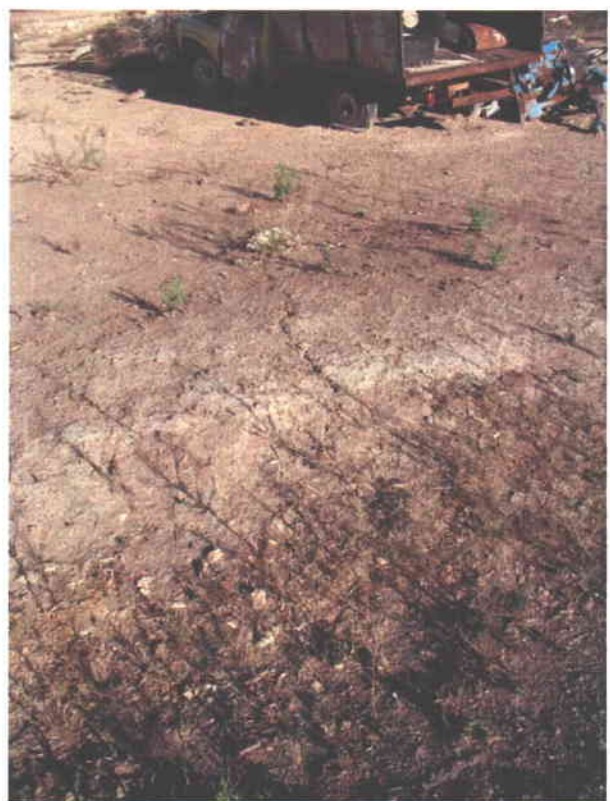
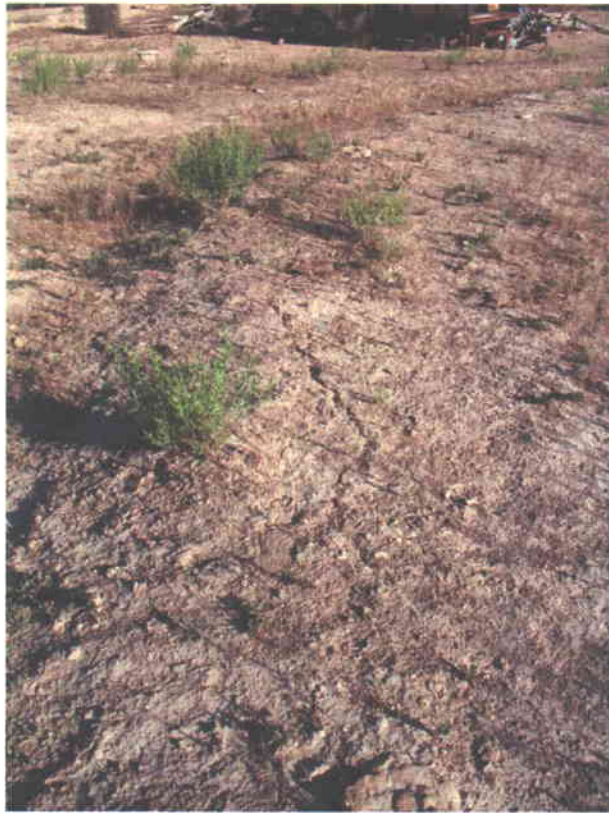
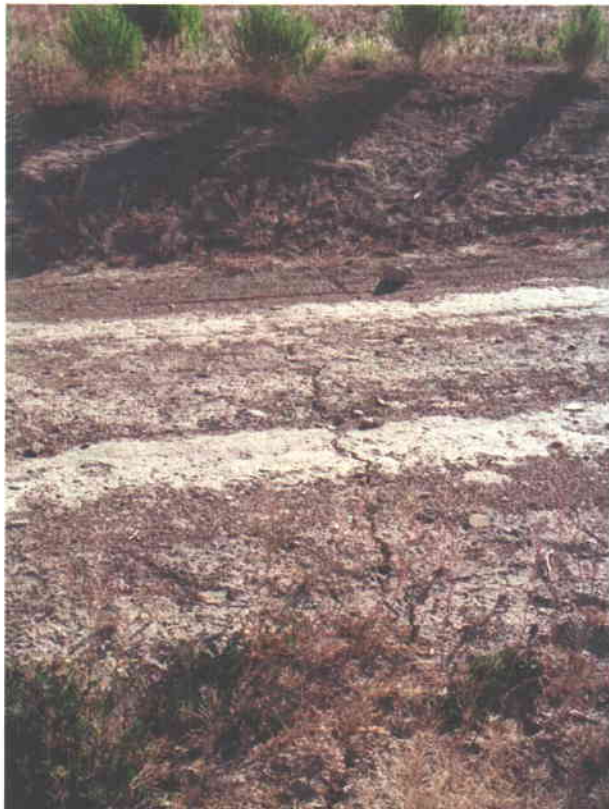
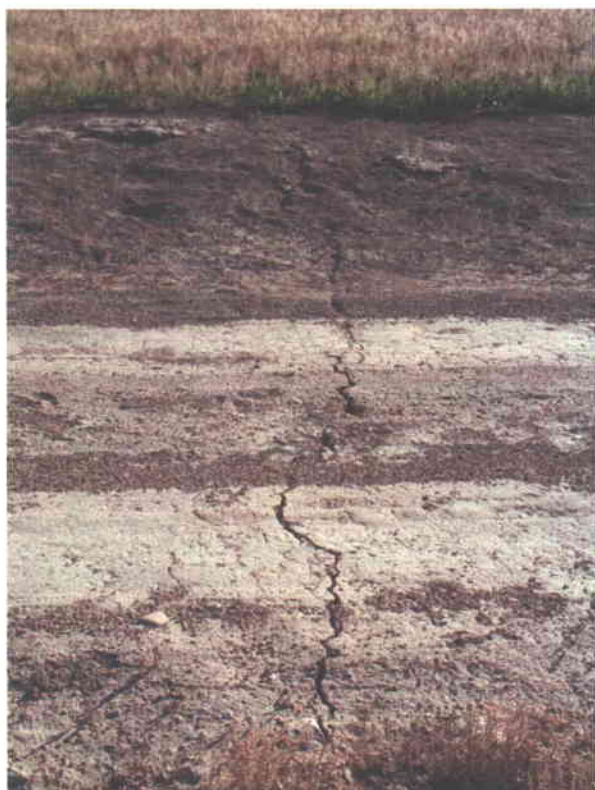
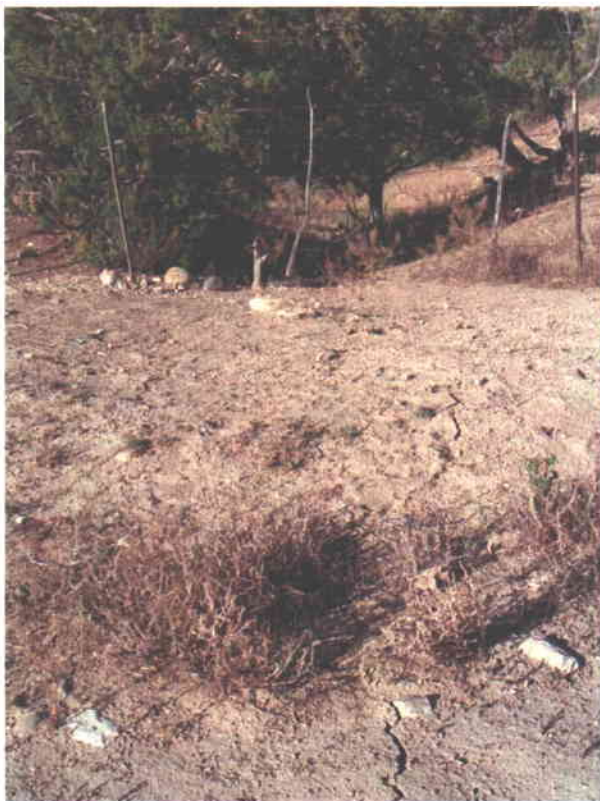
6-8-07

Few cracks over Panel 14 West pictures were taken. PB
